Fouling autopsy of hollow-fibre MF membranes in wastewater reclamation

Diagnosing fouling of hollow fibre MF membranes in wastewater reclamation

Long D. Nghiem and Andrea I. Schäfer *

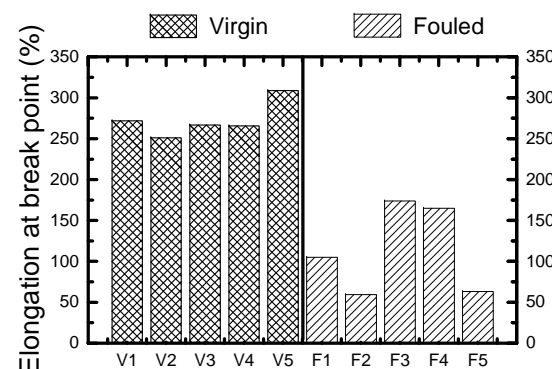
Figure 4: Elongation at break point of the fouled membrane fibres as compared to virgin membrane fibres.

In this case, it appears that the fouled membrane has become more brittle, possibly because the membrane has been allowed to dry prior to testing. This may also be attributed to normal wear and tear during the filtration process and backflush operation. A significant variation in elongation at break point can also be observed for the fouled membrane. However, it is interesting to note that both fouled and virgin membranes have approximately the same young modulus, yield point & elastic profile (data not shown). No clear evidence of material degradation could be observed for the membranes investigated.

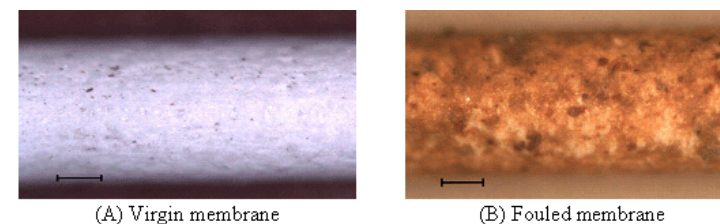
A picture of the virgin, as well as fouled membranes is shown in Figure 6. Visual investigation reveals a strong discolouration of the fouled membranes with a reddish fouling layer. The fouled membrane also demonstrates a severe expansion of the fibres, presumably due to the mechanical stress of filtration and backflushing. Some fragile and brittle characteristics upon touching, in particular near the end of the modules where the fibres were attached to the plotting resin, can also be observed. This is consistent with the results obtained from mechanical testing described above.

Figure 5: Light microscopic pictures of a virgin membrane (A) and fouled membrane (B). Bar presents 150 µm.

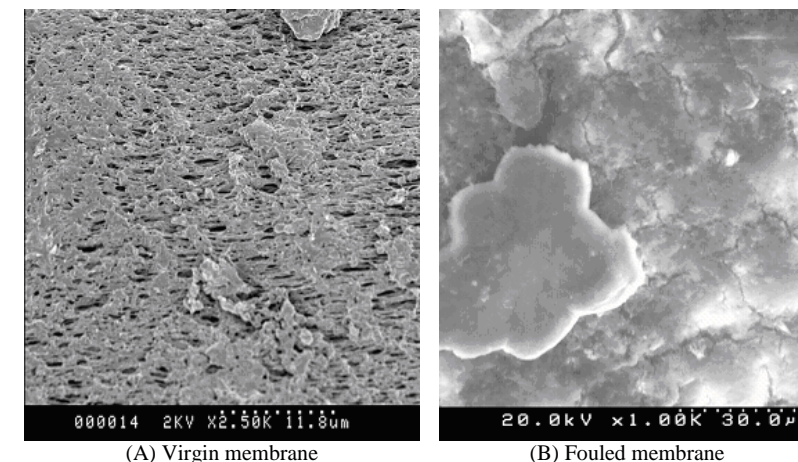
Figure 6: Electron microscopic pictures of a virgin membrane (A) and fouled membrane (B) taken by the FESEM.

The fouling layer morphology is further examined in detail and an electron microscopic picture of the fouling layer is shown in Figure 6. An electron microscopic picture of the clean membrane surface is also presented for comparison purposes. Schäfer *et al.* [1] methodically summarise four distinctive common fouling categories namely scaling/inorganic, organic, colloidal/particulate, and biofouling. There is no evidence of bacteria or fungi on the fouling layer and biofouling is unlikely the main cause in this instance. Figure 6 reveals a firm cake layer on the membrane surface. This cake layer is probably made up of organic matters or colloidal particles or most likely the combination of both. While scaling is uncommon in microfiltration processes and no evidence of crystallisation can be observed on the fouling layer, it is possible that multivalent cations, for example Ca^{2+} , can act to cement colloidal particles, organic matters, and the membrane surface one another as previously shown in another of our study [10]. This phenomenon has also been exquisitely examined by Li and Elimelech by measuring attractive force between these entities with and without the presence of multivalent cations [11].

It is noteworthy that a reddish colour observed in Figure 6 may reflect the presence of iron oxide. Clays together with silica colloids are typical particulate matters encountered in exhibit and road hose down runoffs, which make up most of the influent in this case, in particular during the construction phase. This hypothesis can be confirmed by examining the elementary composition of the fouling layer and foulant characterisation as showed in the following section.

Mechanical testing indicates that no material degradation of the membrane due to exposure to oxidants or any other chemical agents has occurred, although the fouled membrane fibres appear to be slightly more brittle. Visual observation by light microscopy and FESEM combined with the results from foulant composition analysis consistently reveals that the membrane has been fouled with a mixture of colloidal particles and organic matter. Complexation and other interactions between multivalent cations, organic matter, and colloidal particles have most likely worsened the fouling process caused by the suspended solids load itself. It is advisable to enhance pre-treatment prior to the MF unit, possibly by applying coagulants, to maintain a low and stable turbidity level in the feed. Chemical cleaning protocol and air backflushing frequency may also need to be modified for an optimal fouling mitigation approach. Monitoring of the feedwater composition over a period of time will provide further insight into the fouling process.

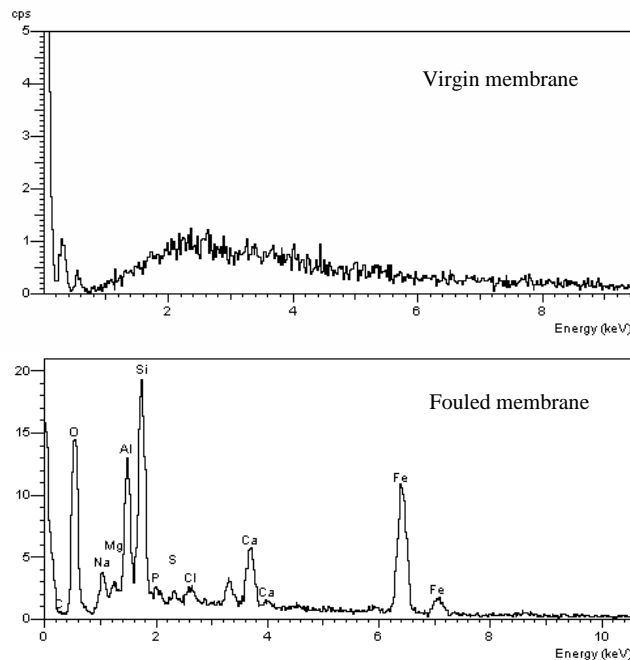
The presence of metallic elements such as ion, aluminium, calcium, and magnesium is clearly evident in the energy dispersive X-ray (EDX) spectrometry graph of the fouling layer as shown in Figure 8. A significant amount of silica can also be observed. Furthermore, Figure 8 reveals a large peak of oxygen and trace amount of other non-metallic elements such as chlorine, sulphur, and phosphate. Such significant amount of oxygen may be attributed to organic matters present in the fouling layer, although it is prudent to note that it can also be from the membrane polymeric material. While a small peak of oxygen can be observed in the EDX spectrometry graph of the virgin membrane, no chlorine, sulphur, or phosphate can be found (see Figure 8).

Figure 7: Energy dispersive X-ray spectrometry of the virgin membrane surface (top) and the foulant layer (bottom). Excitation energy was set at 20 000 kV (note difference in y-axis scale).
